ULTRASONIC DETECTION OF SURFACE FLAWS IN GAS TURBINE CERAMICS.(U)

AUG 79 T DERKACS , I M MATAY

TRW-ER-7980-F

4. TITLE (and Subtitle) ULTRASONIC DETECTION OF SURFACE FLAWS IN GAS TURBINE CERAMICS		5. TYPE OF REPORT & PERIOD COVERED Final Technical Report	13 Sep 77-12 kluc 78

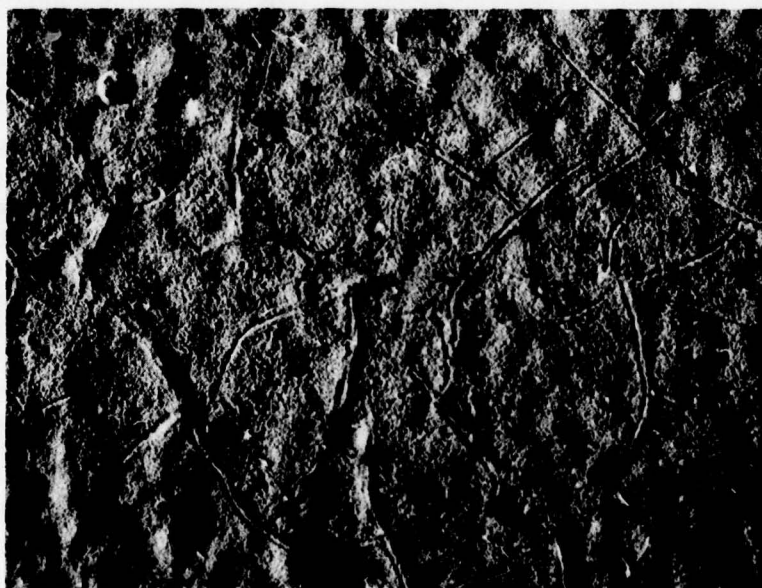
Area A

Area B

Evaluation of the surface wave inspection results showed a correlation between the areas showing large numbers of defect indications and visible surface features. As an example, Figure 20 shows 7X photomicrographs of two areas, designated A and B, which are indicated on Figures 16 and 17. Figure 20 shows that the indications in areas A and B were caused by high concentrations of randomly oriented surface creases. Such creases were not present in areas of the surface where there were no indications.

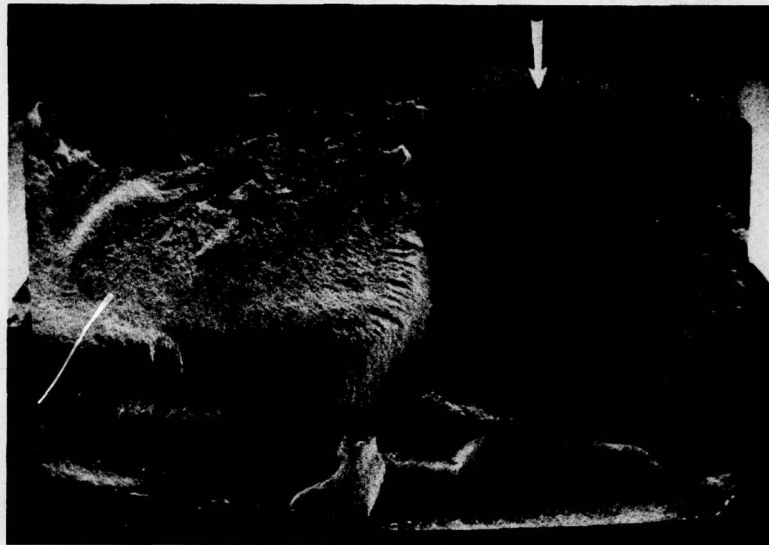
Figure 65. Fracture Surface of Ceralloy 147A HPSN Specimen No. 2 Showing Ultrasonically Detected Defect at Fracture Origin.

The fracture origin in specimen No. 2 can be seen in Figure 65 to be a surface pit, 180 μm (0.007 inches) wide by 75 μm (0.003 inches) deep. The fracture origin in specimen No. 3 can be seen in Figure 66 to be an area of large crystals extending down from the surface. It is about 500 μm (0.020 inches) across and 350 μm (0.014 inches) deep. This is defect E in Figures 23 and 24. The fracture origin in specimen No. 4 can be seen in Figure 67 to be a flake-like inclusion oriented parallel to the specimen surface. It is about 400 μm (0.016 inches) long, 50 μm (0.002 inches) wide and located about 100 μm (0.004 inches) below the surface. This is defect A in Figures 21 and 22. In comparing the defects that have been examined in specimen Nos. 2, 3 and 4 with the other indications in Figures 21 through 24, it can be seen that these are among the largest defects that were detected.

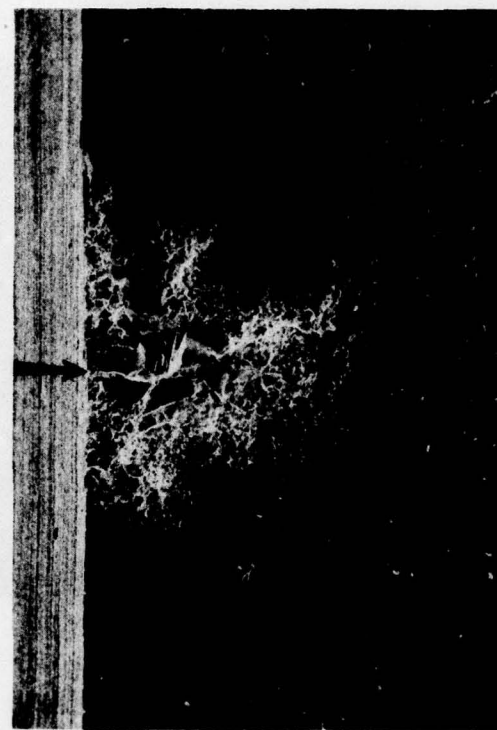
Figure 66. Fracture Surfaces of Ceralloy 147A HPSN Specimen No. 3, Showing Ultrasonically Detected Defect at Fracture Origin.

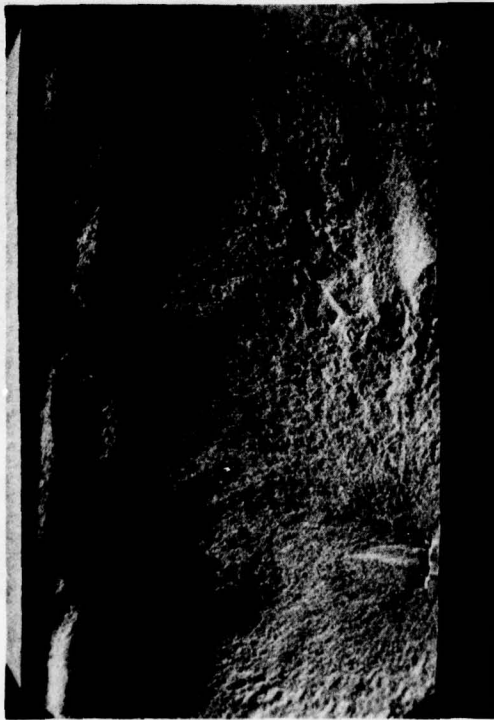
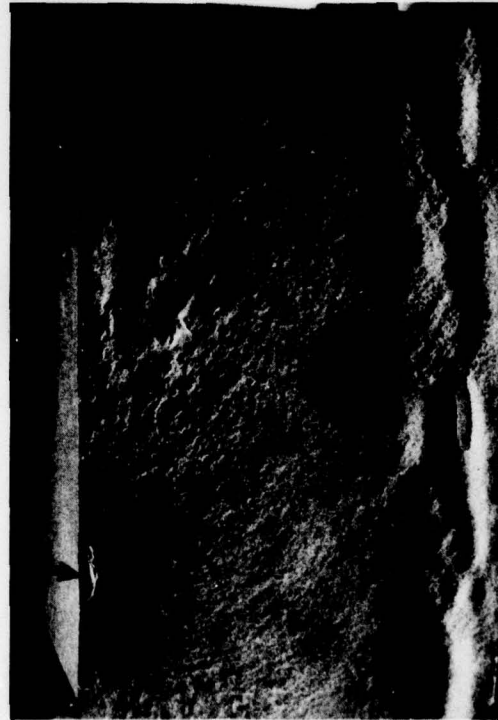
Figure 67. Fracture Surfaces of Ceralloy 147A HPSN Specimen No. 4, Showing Ultrasonically Detected Defect at Fracture Origin.

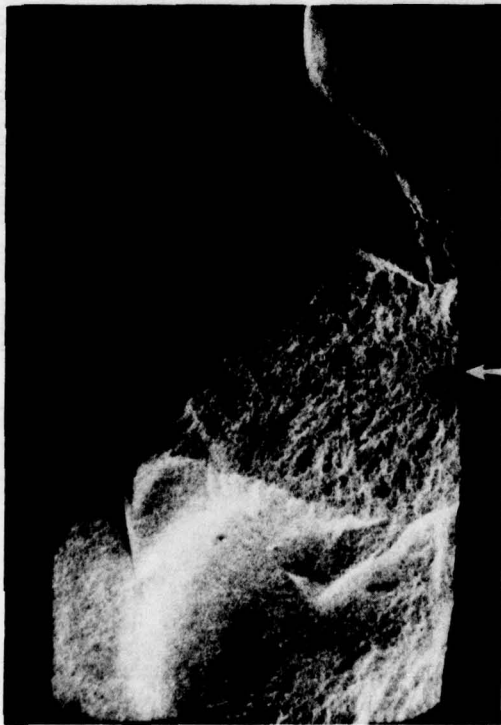
Figure 68. Fracture Surfaces of Ceramloy 147A HPSN Specimen No. 6, Showing 1kg Vicker's Indentation at Fracture Origin.

Figure 68 shows the fracture surfaces of specimen No. 6. The Vicker's indentation cannot be identified by a pit on the surface, although it is possible that it was lost due to shattering of the specimen. The fracture origin is a crack about 60 μm (0.0024 inches) deep which is assumed to be the result of the indentation. Figure 69 shows the fracture surface of specimen No. 9. The indentation consists of a 140 μm (0.0056 inch) wide x 40 μm (0.0016 inch) deep pit with a crack extending about 530 μm (0.0212 inches) deep. This specimen was the weakest of the group with a strength of only 109 MN/m^2 (15.8 ksi). Even specimen No. 3, which had an inclusion almost as large, had a strength of 341 MN/m^2 (49.4 ksi). Specimen No. 6, on the other hand, had a strength of 486 MN/m^2 (70.6 ksi) which is slightly higher than the strength of specimens No. 10 and 11, which were machined perpendicular to the grinding marks. This indicates that a 1 kg Vicker's indentation probably would not have been a fracture origin, i.e., a strength limiting defect, in a specimen machined perpendicular to the grinding direction.

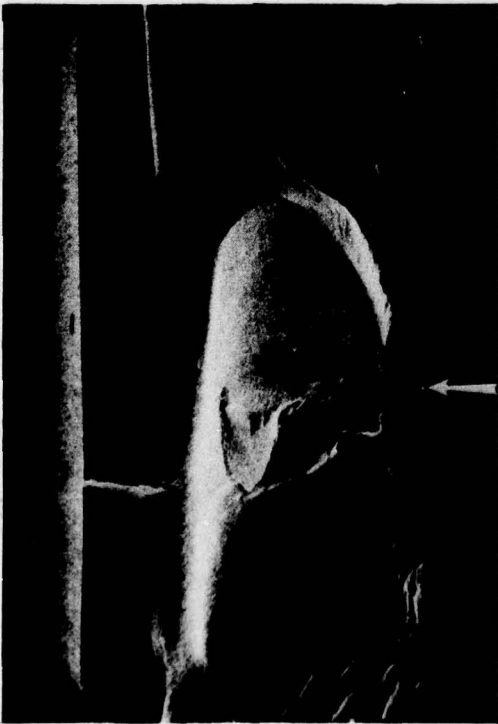
Figure 70. Fracture Surfaces of NC-132 HPSN Specimen No. 1, Showing Ultrasonically Detected Defect at Fracture Origin.

Figure 70 shows the fracture surfaces of specimen No. 1 of NC-132 HPSN. The fracture origin is seen to be an area of large grains $16\text{ }\mu\text{m}$ (0.0006 inches) wide by $20\text{ }\mu\text{m}$ (0.0008 inches) deep. The location of the defect as well as its size correlate well with the indication in Figure 29. The fact that the same indication was not seen in Figure 31 cast some doubt on the correlation. However, with such a small defect, this may simply be normal statistical variation in sensitivity. Specimens No. 2 and No. 3 do not appear to have fractured through the ultrasonically detected defects. Specimen No. 2 broke from a fracture origin at the surface (see Figure 71) associated with several 10 to $20\text{ }\mu\text{m}$ (0.0004 to 0.0008 inch) grains. Specimen No. 3 broke through a fracture origin at the surface in which no defect could be identified.

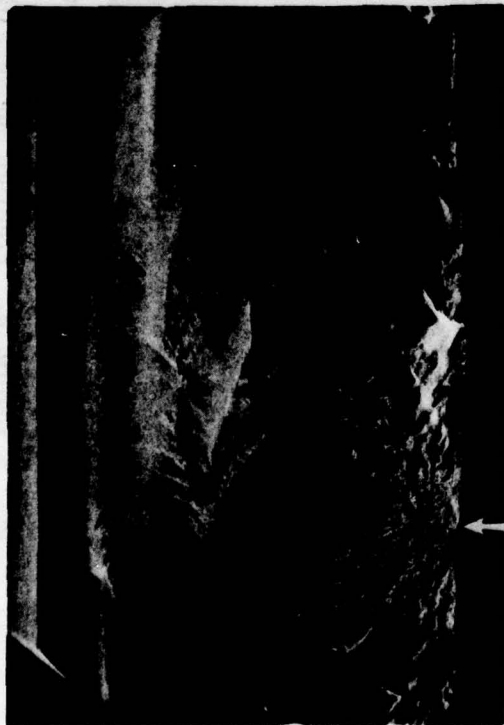
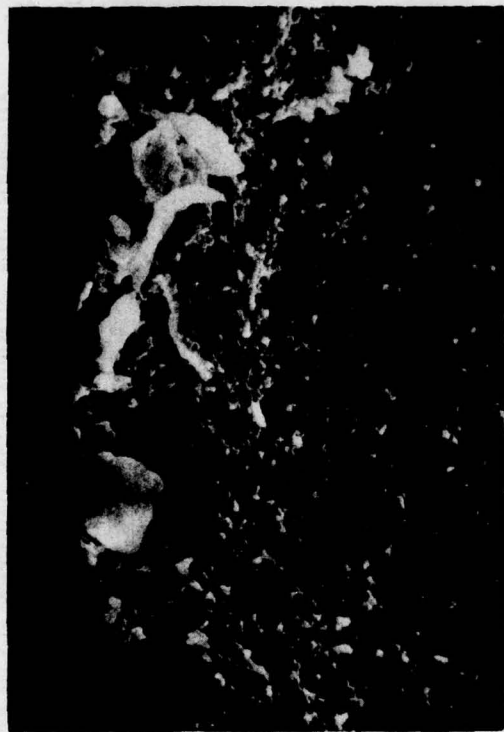
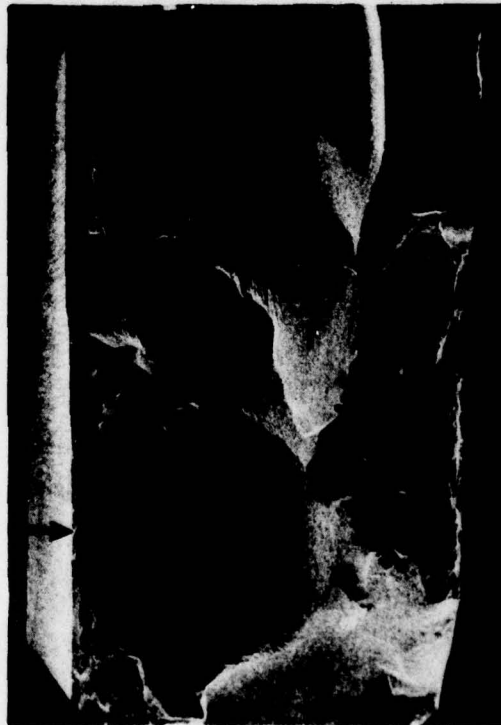
Figure 71. Fracture Surfaces of NC-132 HPSN Specimen No. 2, Showing Fracture Origin.

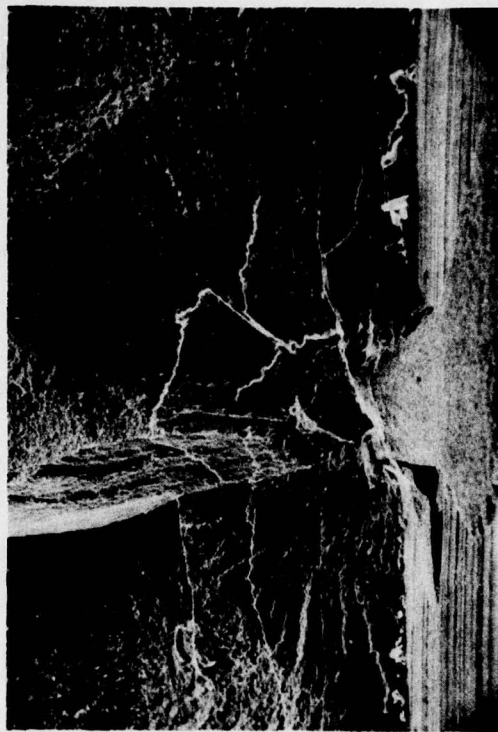
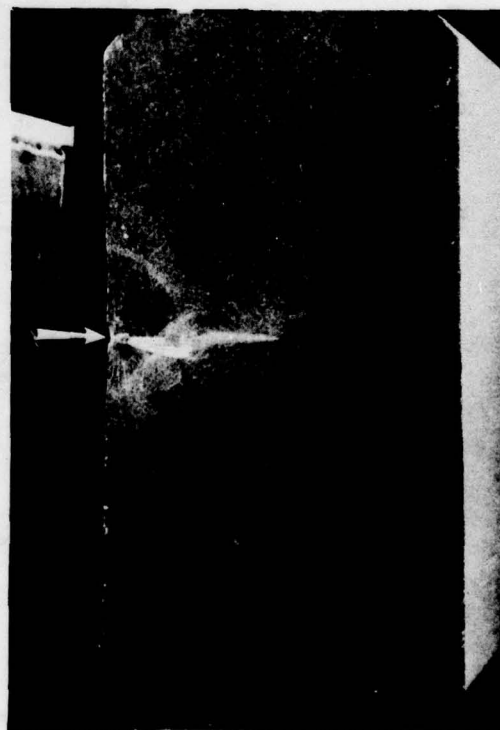
Figure 72. Fracture Surfaces of NC-132 HPSN Specimen No. 7, Showing 50 kg Vicker's Indentation at Fracture Origin.

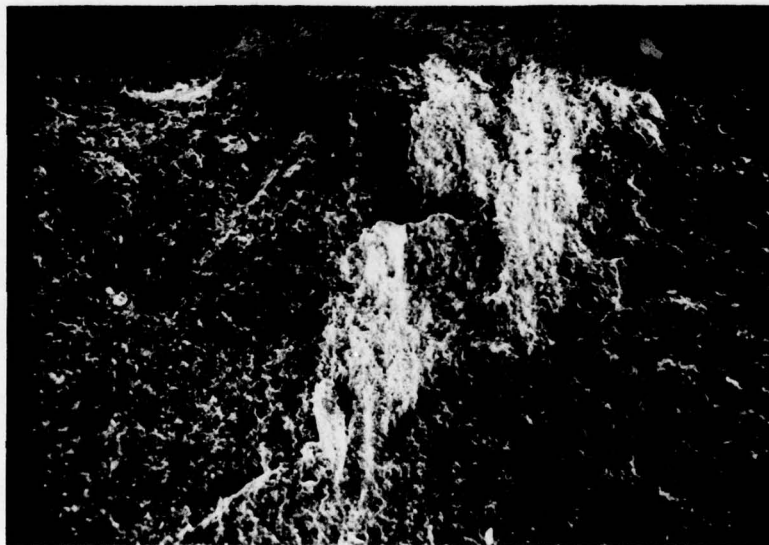
Figure 73. Fracture Surfaces of NC-350 RBSN Specimen No. 12, Showing 50 kg Vicker's Indentation at Fracture Origin.

Specimen No. 12, which contained a 50 kg Vicker's indentation, broke in two along a diagonal when the indentation was made. Figure 73 shows one side of the fracture surface. The pit is about $600 \mu\text{m}$ (0.026 inches) across and $200 \mu\text{m}$ (0.0079 inches) deep and the crack extends all the way through the $3150 \mu\text{m}$ (0.124 inch) thickness of the specimen. Specimen 15, which contained a 1 kg Vicker's indentation, broke at a low strength and shattered so that it was not possible to determine if it fractured from the indentation or not.

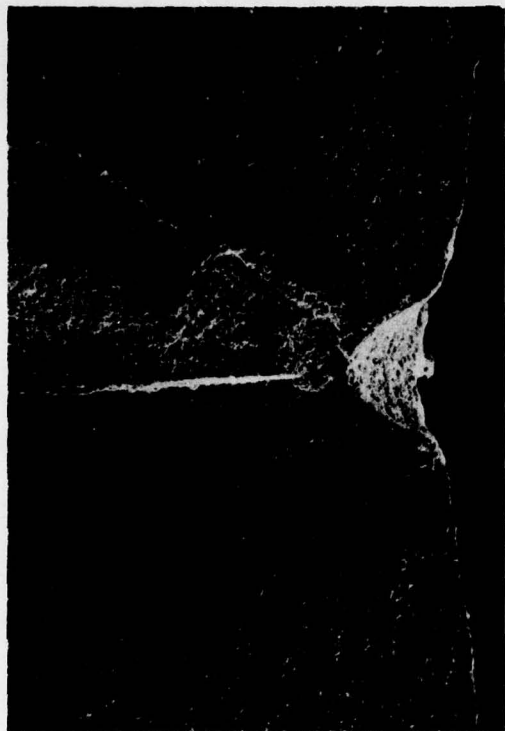
Figure 74. Fracture Surfaces of Ceralloy 146A HPSiC Specimen No. 1, Showing 50 kg Vicker's Indentation at Fracture Origin.

The results of the four-point-bend tests on HPSiC are listed in Table III. Specimens 1 and 4 of Ceralloy 146 contained the 50 kg and 1 kg Vicker's, respectively. The fracture surfaces of these specimens are shown in Figures 74 and 75. In Figure 74 it can be seen that the 50 kg Vicker's indentation consisted of a pit $200 \mu\text{m}$ (0.008 inches) wide by $160 \mu\text{m}$ (0.0064 inches) deep with a crack extending $605 \mu\text{m}$ (0.0242 inches) deep. The 1 kg Vicker's indentation shown in Figure 75 consists of a pit $20 \mu\text{m}$ (0.0008 inches) wide by $2 \mu\text{m}$ (0.00008 inches) deep with a crack extending about $25 \mu\text{m}$ (0.0010 inches) deep. Specimens 2 and 3 of Ceralloy 146, which were machined perpendicular to the grinding damage, had an average strength of $429 \pm 16 \text{ MN/m}^2$ ($62.3 \pm 2.3 \text{ ksi}$) compared to $509 \pm 61 \text{ MN/m}^2$ ($73.8 \pm 8.8 \text{ ksi}$) for specimens 5 and 6 which were machined parallel to the grinding direction. While this difference is large, there is too much scatter in the data and too few specimens to conclude that it is significant with a high degree of confidence. The specimen containing the 1 kg Vicker's was significantly weaker, 299 MN/m^2 (43.3 ksi) than those machined perpendicular to the grinding damage. Specimens 2, 3, 5 and 6 all failed through identifiable fracture origins in which no specific defect could be identified.

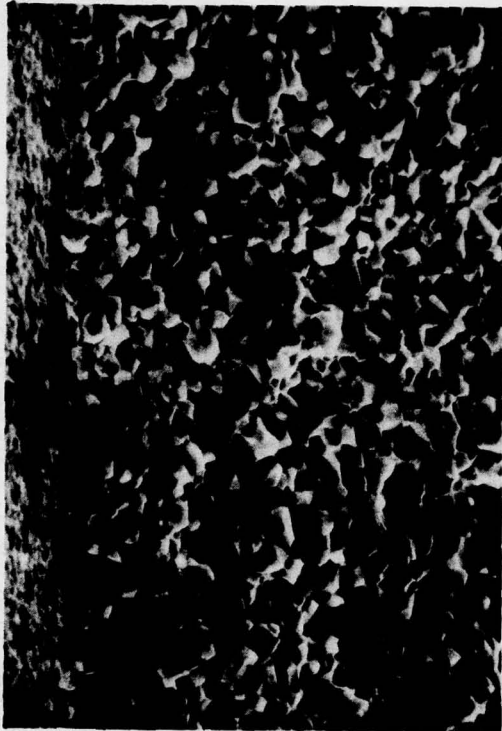
Figure 75. Fracture Surfaces of Ceralloy 146A HPSiC Specimen No. 4, Showing 1 kg Vicker's Indentation at Fracture Origin.

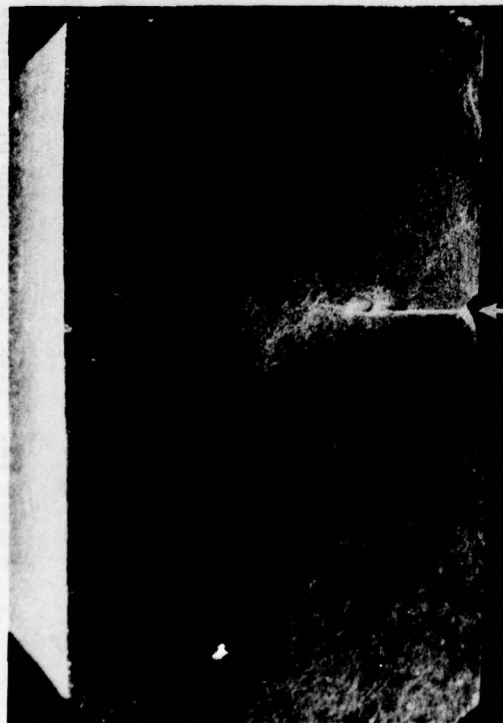
Figure 76. Fracture Surfaces of NC-230A HPSiC Specimen No. 1, Showing 50 kg Vicker's Indentation at Fracture Origin.

Specimens 1 and 4 of NC-230 also contain 50 kg and 1 kg Vicker's indentations, respectively. The fracture surfaces of these specimens are shown in Figures 76 and 77, respectively. In Figure 76 it can be seen that the 50 kg Vicker's indentation consists of a $200 \mu\text{m}$ (0.0008 inch) wide by $160 \mu\text{m}$ (0.0064 inch) deep pit with a $510 \mu\text{m}$ (0.0204 inch) deep crack. The 1 kg Vicker's indentation shown in Figure 77 consists of a $20 \mu\text{m}$ (0.0008 inch) wide by $5 \mu\text{m}$ (0.0002 inch) deep pit with a $35 \mu\text{m}$ (0.0014 inch) deep crack. Specimens 2 and 3 were machined in an area of heavier grinding damage while specimens 5 and 6 were machined in an area of lighter grinding damage, but all specimens were machined perpendicular to the damage. Specimen 2 was damaged during finish machining and was not tested. Specimen 3 had a strength of 412 MN/m^2 (59.8 ksi) compared to $504 \pm 13 \text{ MN/m}^2$ ($73.1 \pm 1.9 \text{ ksi}$) for specimens 5 and 6. Here again there is a considerable difference in strengths which corresponds with the ultrasonic results, but the data is insufficient to draw a statistically valid conclusion. Specimens 7, 8 and 9 were from an area that showed extensive ultrasonic indications, not only by the surface wave technique, but also by shear and longitudinal wave techniques. The average strength of these specimens was $187 \pm 21 \text{ MN/m}^2$ ($27.2 \pm 3.1 \text{ ksi}$). This is significantly lower than the average of specimens 3, 5 and 6, 473 ± 54

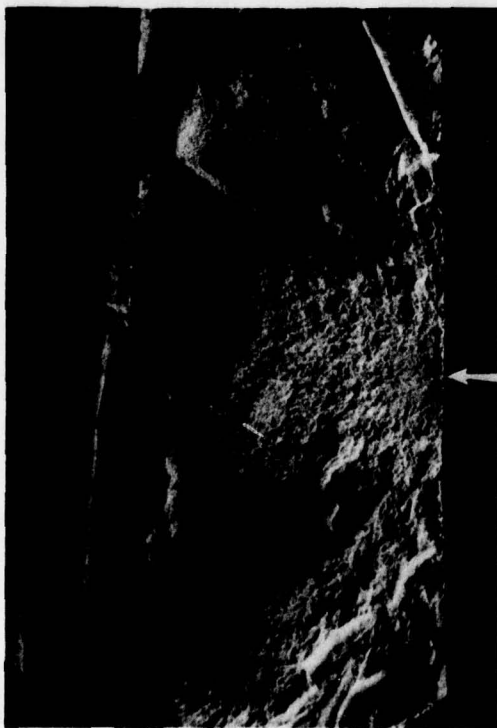
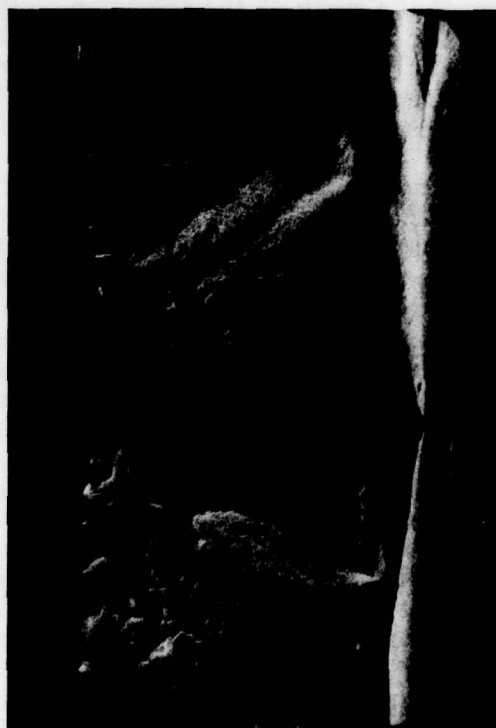
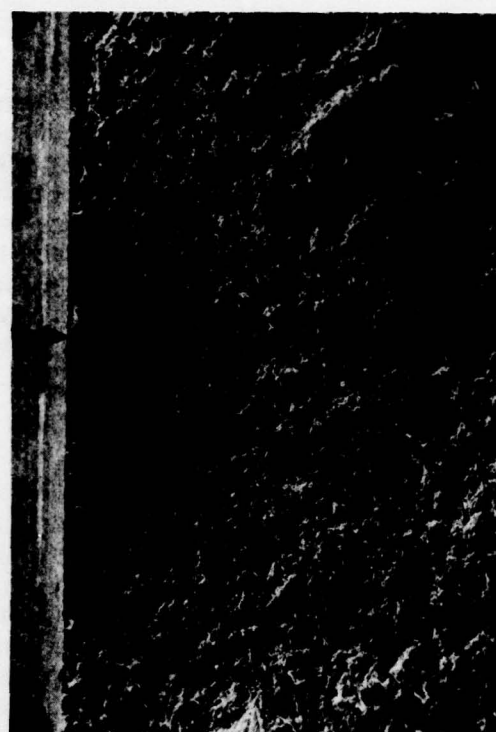
Figure 77. Fracture Surfaces of NC-230A HPSiC Specimen No. 4, Showing 1 kg Vicker's at Fracture Origin.

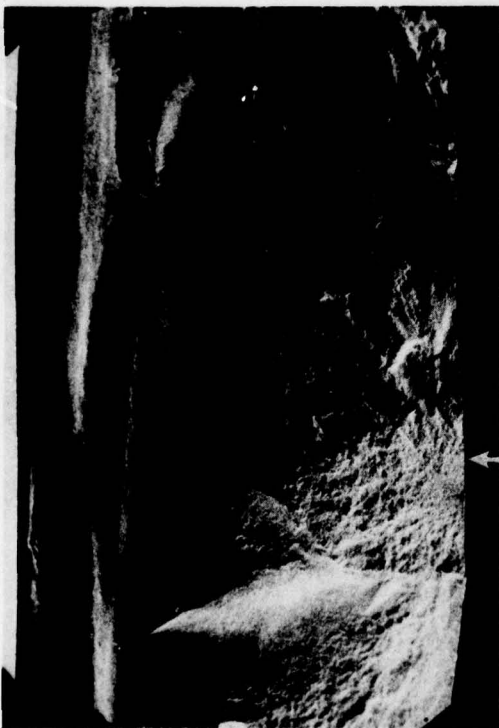
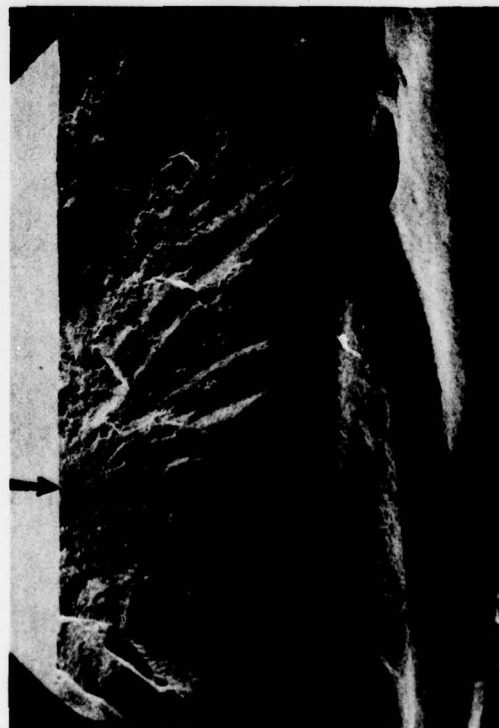
Figure 78. Fracture Surfaces of NC-203A HPSiC Specimen No. 6 (Typical Sound Material With Light Grinding Damage).

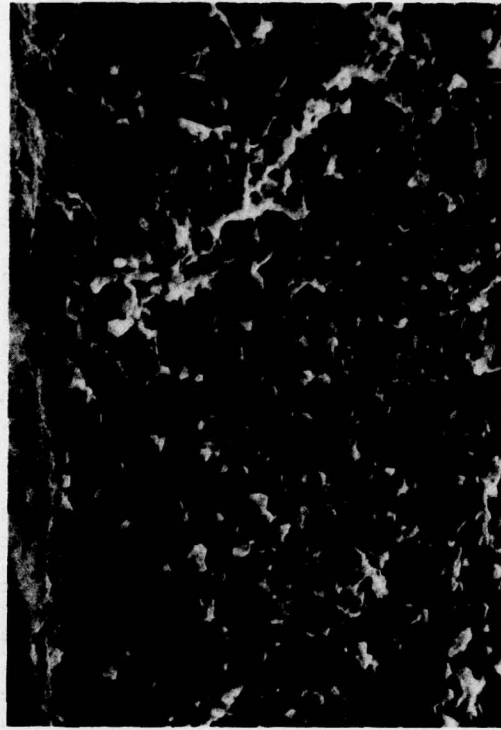
Figure 79. Fracture Surfaces of NC-203A HPSIC Specimen No. 7 (Typical Defective Material).

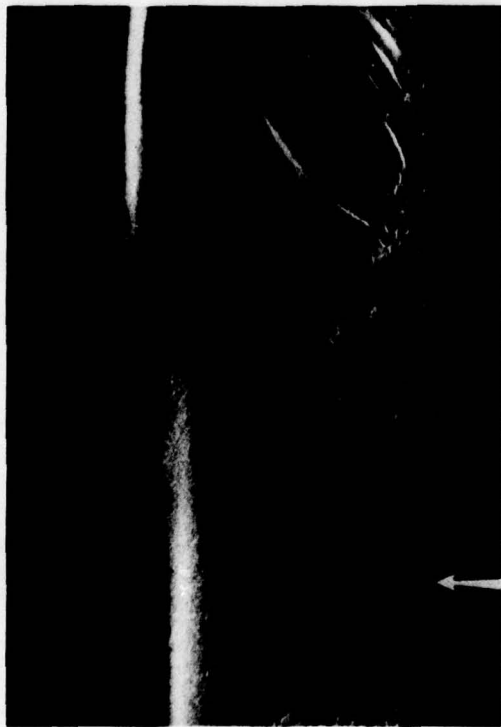
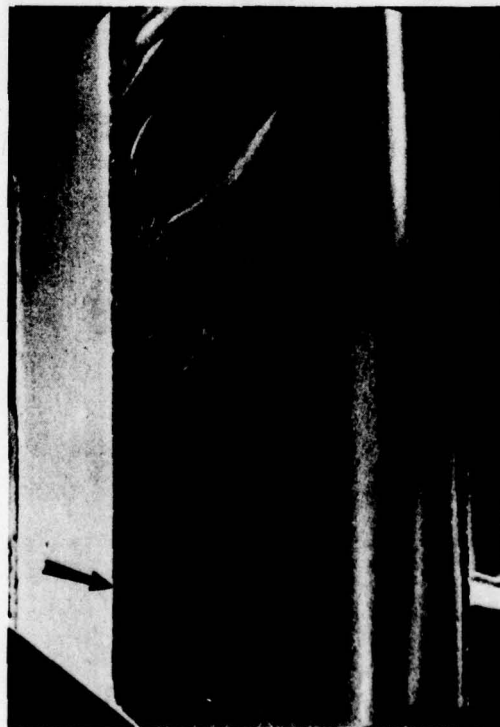
Figure 80. Fracture Surfaces of Boron Doped SSiC Specimen No. 1, Showing Fracture Origin Along Ultrasonically Detected Linear Defect.

The results of the four-point-bend tests on boron-doped SSiC are listed in Table IV. All the specimens were machined perpendicular to the grinding damage. As can be seen in Figure 59, specimen No. 1 contained a severe individual linear defect indication. It failed at the defect location at a strength of only 192 MN/m^2 (27.9 ksi). Specimen No. 2 contained machining damage less severe than the defect in specimen 1. It failed at the defect location at a strength of 358 MN/m^2 (51.9 ksi). Specimens 3 and 4 showed no machining damage at the sensitivity of inspection. Their average strength was $423 \pm 27 \text{ MN/m}^2$ (61.4 - 3.9 ksi). Figure 80 shows the fracture surfaces of specimen No. 1. While there is a well defined fracture origin at the surface near one corner, the failure appears to have propagated along a line of pre-existing surface damage over most of the width of the specimen. Figure 81 shows 100X views of this damage away from the fracture origin. The depth of the defective area is estimated to have been about $50 \mu\text{m}$ (0.0020 inches). Specimen No. 2 shows similar results, except that the defect depth is only about $15 \mu\text{m}$ (0.0006 inches). Specimens 3 and 4 shattered so badly that a fracture origin could not be identified.

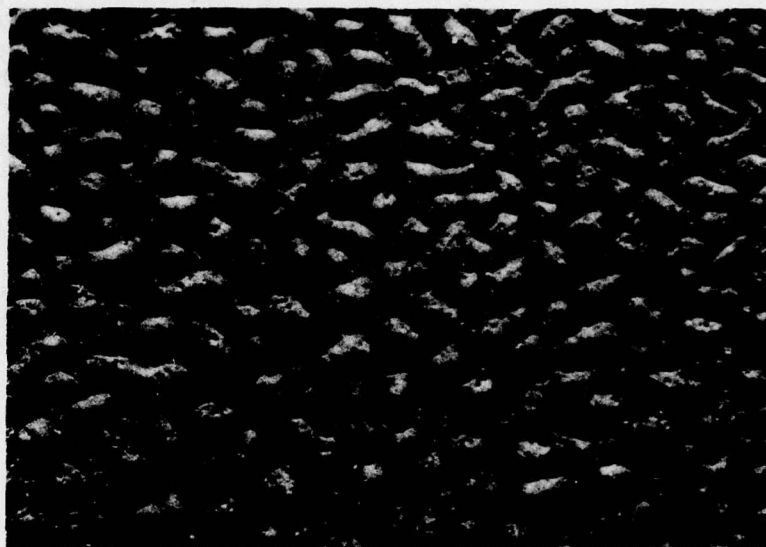
a. Back Side

b. Flame Side

Figure 87. Photomicrographs of Typical Burner Rig Specimen Surfaces After Testing, Showing Beads of Fused Silica.

The condition that made the specimens uninspectable is shown in Figure 87. The surface became covered with material that had the appearance of droplets of liquid that had solidified on the surface. These beads were transparent and varied in size, being smallest at the point where the center of the flame struck the specimen and getting larger with decreasing temperature. The largest beads were on the backsides of the specimens. Although each of the specimens had this condition, the distribution of sizes varied from one to the other. The possibility that the deposit was salt was considered. However, efforts to remove it using water or soap and water were unsuccessful.

Following final inspection of the specimens, electron microprobe analysis was run on the specimens to determine the nature of the surface deposits. The only elements found in large concentrations on the surface of the parts were silicon and oxygen. It was concluded that the surface condition was the result of fused silica beading up on the surface of the material.
